Client Report :

Assessment of energy
efficiency impact of Building
Regulations compliance

Client report number
219683

10 November 2004

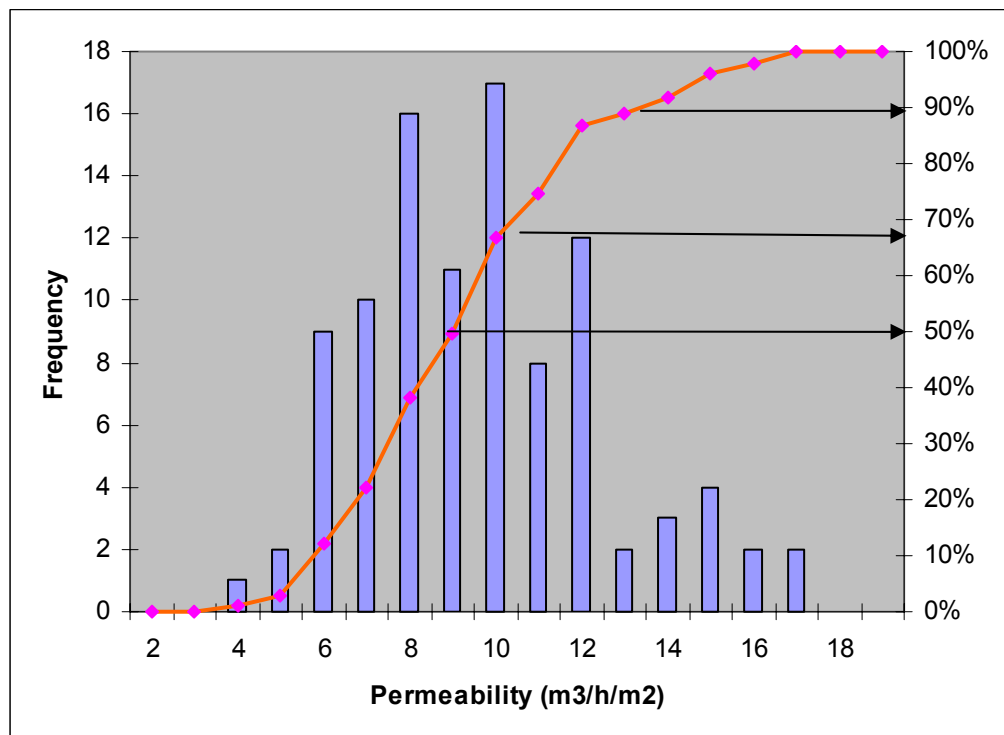
Figure 1. Distribution of measured air permeabilities ($\text{m}^3/\text{h}/\text{m}^2$ at 50Pa)

- The range of air permeabilities was from 3.2 to 16.9 $\text{m}^3/\text{h}/\text{m}^2$ at 50 Pa, with a mean of 9.2 $\text{m}^3/\text{h}/\text{m}^2$ at 50 Pa
- Two-thirds (68%) of the sample had achieved the recommended maximum level of 10 $\text{m}^3/\text{h}/\text{m}^2$ at 50 Pa, or better.
- Half of the sample achieved 9 $\text{m}^3/\text{h}/\text{m}^2$ at 50 Pa, or better.
- 90% of the sample achieved 13 $\text{m}^3/\text{h}/\text{m}^2$ at 50 Pa, or better.
- The remaining 10% of the sample achieved between 13 and 17 $\text{m}^3/\text{h}/\text{m}^2$ at 50 Pa.

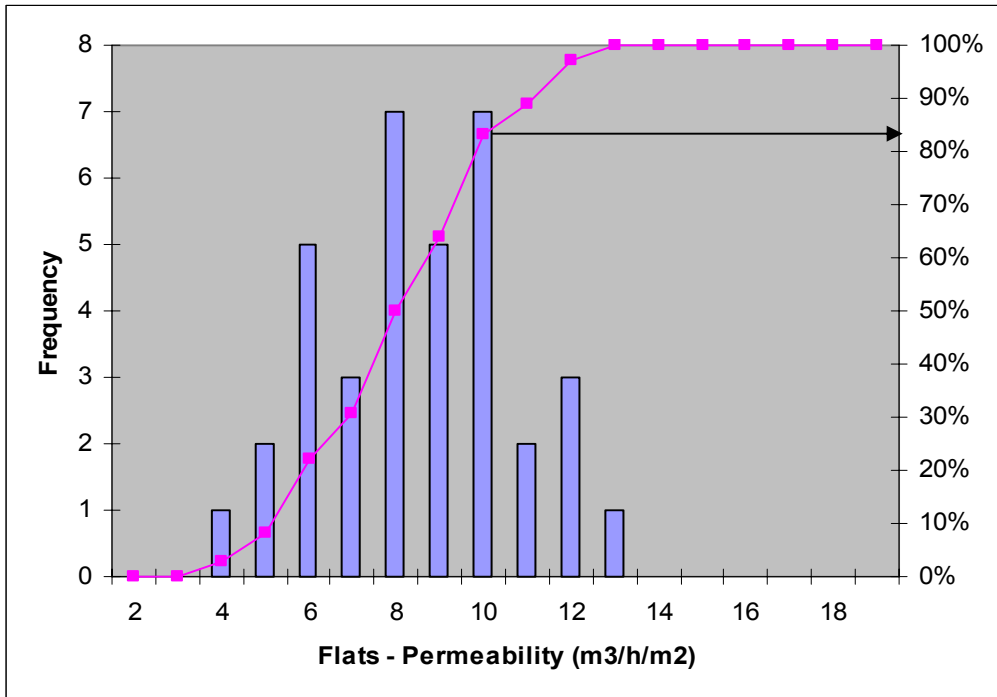
- The range of permeabilities for flats was from 3.2 to 12.4 $\text{m}^3/\text{h}/\text{m}^2$ at 50 Pa, with a mean of 8.0 $\text{m}^3/\text{h}/\text{m}^2$ at 50 Pa.

- 83% of flats had achieved 10m³/h/m² or better
- The range of permeabilities for houses was from 5.6 to 16.7 m³/h/m² at 50 Pa, with a mean of 9.8 m³/h/m² at 50 Pa.
- 57% of houses had achieved 10m³/h/m² or better

Figure 2. Distribution of measured air permeabilities in flats (m³/h/m² at 50Pa)

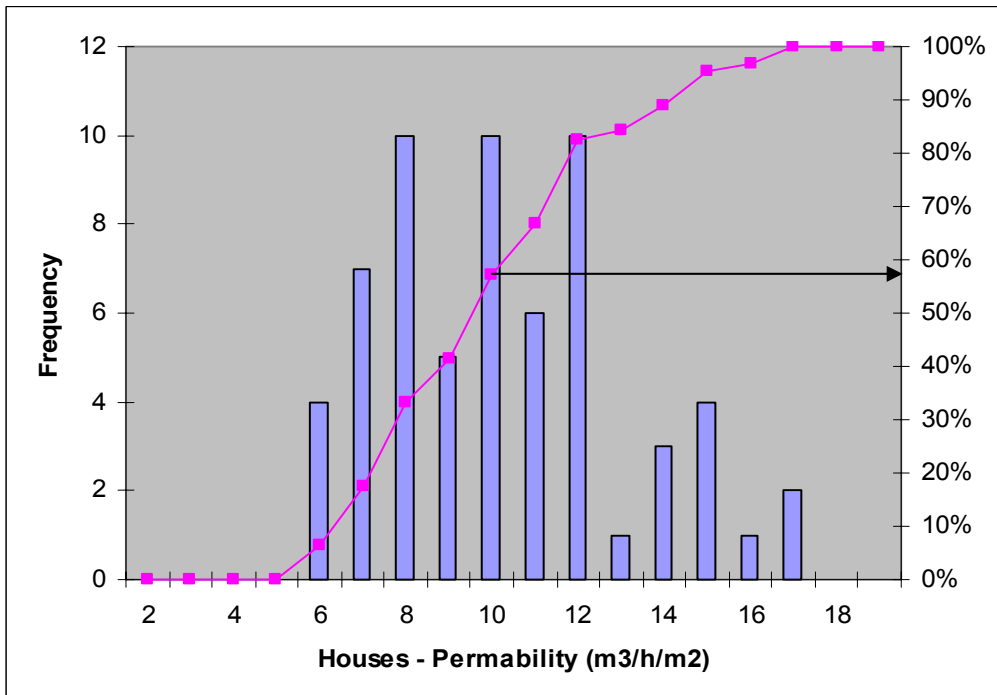
Figure 3. Distribution of measured air permeabilities in houses (m³/h/m² at 50Pa)

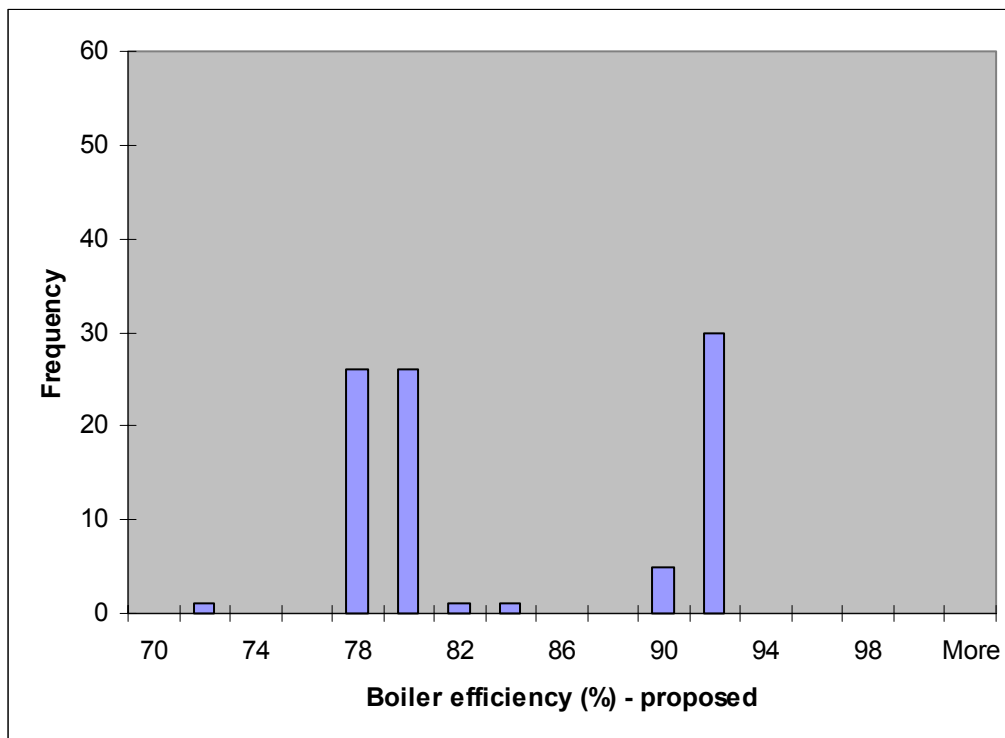
The boiler efficiencies noted in the initial SAP calculations provided by NES are shown below in Figure 4. The Figure shows that the majority of new dwellings are submitted for approval with either an A-rated boiler (90% efficiency or better) or a D-rated boiler (between 78% and 82% efficiency). The efficiencies of the boilers actually installed, shown in Figure 5, indicate that almost 75% of the boilers installed were D-rated boilers. Figure 6 indicates the difference between the 'proposed' and 'as-built' efficiencies. The Figures show the results for the 90 dwellings fitted with gas boilers. Nine dwellings were heated using panel convector heaters.

Figure 4. Efficiencies of boilers noted in initial calculations

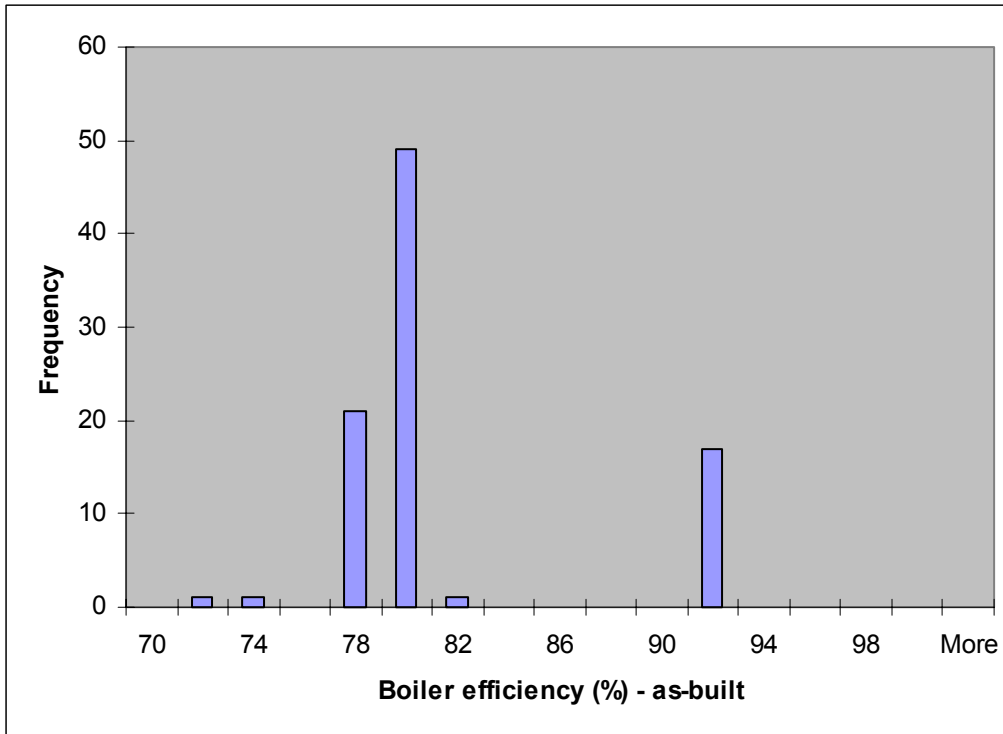
The main differences noted occur where, in 22 dwellings at a number of locations, boilers of about 78% efficiency were observed rather than the 90.5% efficiency that had been indicated by NES' initial SAP calculation. It is not known whether the higher efficiency boilers were originally intended to balance another less efficient aspect of design. However, there were also a small number of dwellings where the difference was reversed, and boilers of 90.5% efficiency were found where the initial calculation had indicated 78%.

Figure 5. Efficiencies of boilers observed 'as-built'

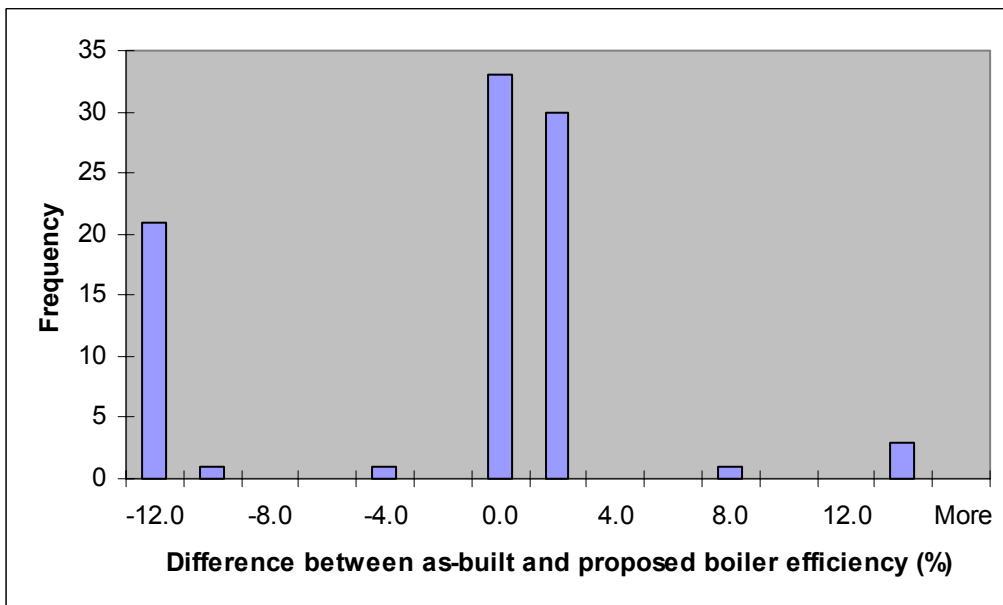
Figure 6. Difference in efficiency in boilers between 'as-built' and calculation

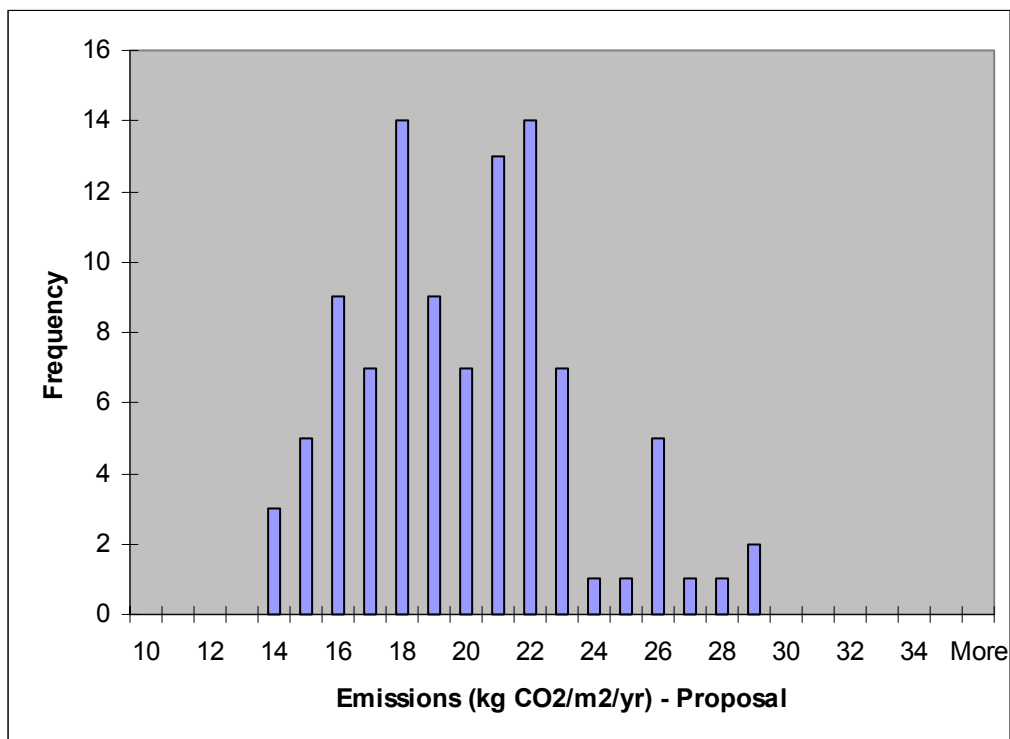
The carbon dioxide emissions originally calculated for the dwellings are summarised in Figure 7. These are based on the SAP/BREDEM calculation method, and using constructional details for each dwelling as input factors. Calculated emissions varied from 13.2 to 28.7kg/m²/yr, with a mean of 19.5 kg/m²/yr.

Figure 7. Carbon dioxide emissions, expected from the initial design details

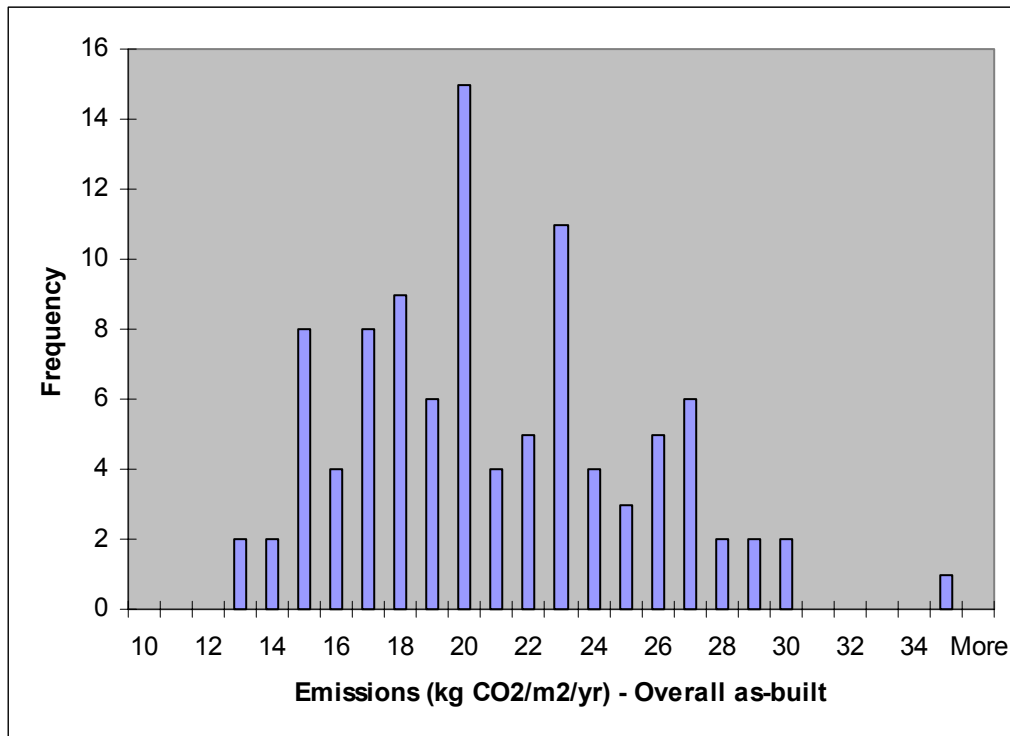
The emissions were recalculated following the air leakage tests and other observations, inputting the air permeability result (expressed in air changes per hour) directly into the calculation, with the results summarised in Figure 8.

The mean as-built emissions were 20.4 kg/m²/yr, representing an average increase in carbon dioxide emissions among the sample of 0.9kg/m²/yr.

Figure 8. Carbon dioxide emissions, resulting from as-built details (boiler and air permeability)

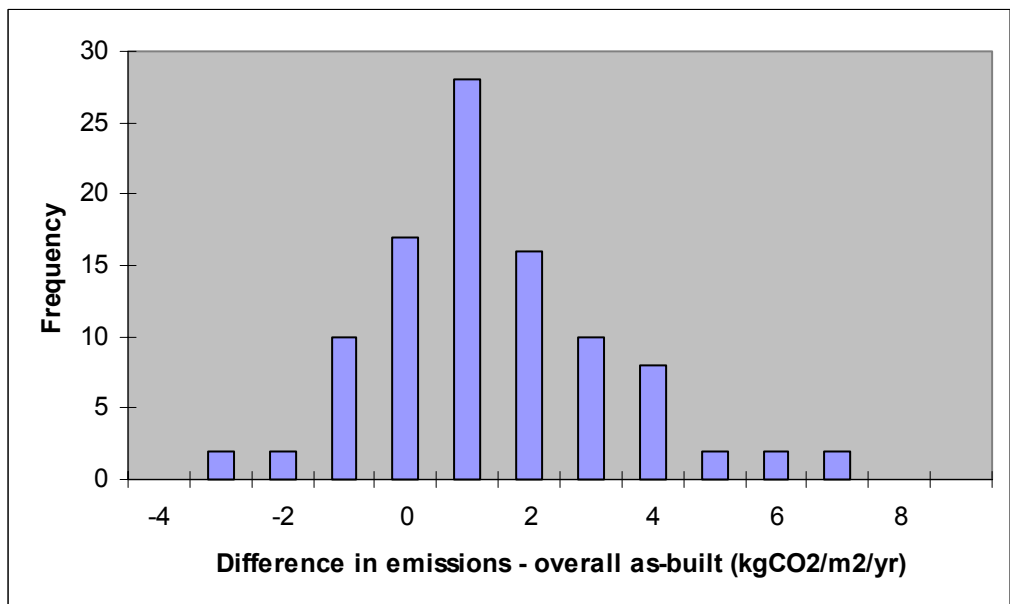
Figure 9 summarises the extent to which the resultant carbon dioxide emissions differed from the original intent. Negative values represent an improvement and positive values a deterioration in performance.

Figure 9. Effect of as-built boiler and air permeability on annual carbon dioxide emissions

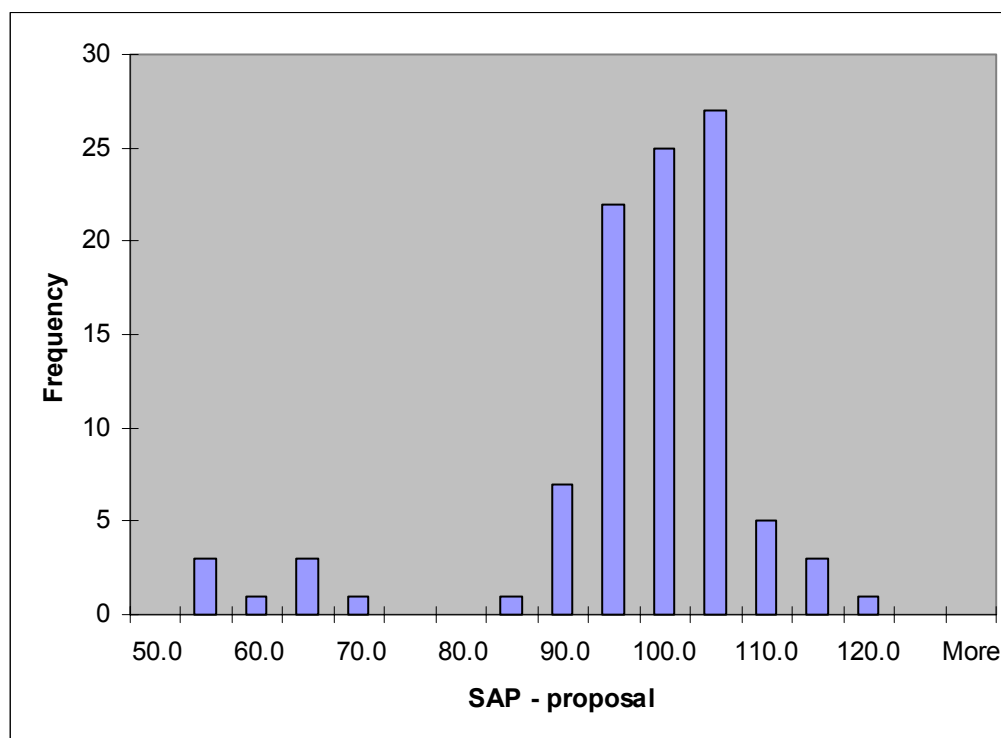
Figure 10 indicates the SAP rating resulting from the 'as designed' dwelling specifications obtained by NES. Calculated SAP values varied from 54 to 112, with a mean of 95.6. The lowest SAP values are associated with the electrically heated dwellings. Among the gas heated dwellings the mean calculated SAP value was 96.7.

Figure 10. SAP calculated using 'as designed' dwelling specifications

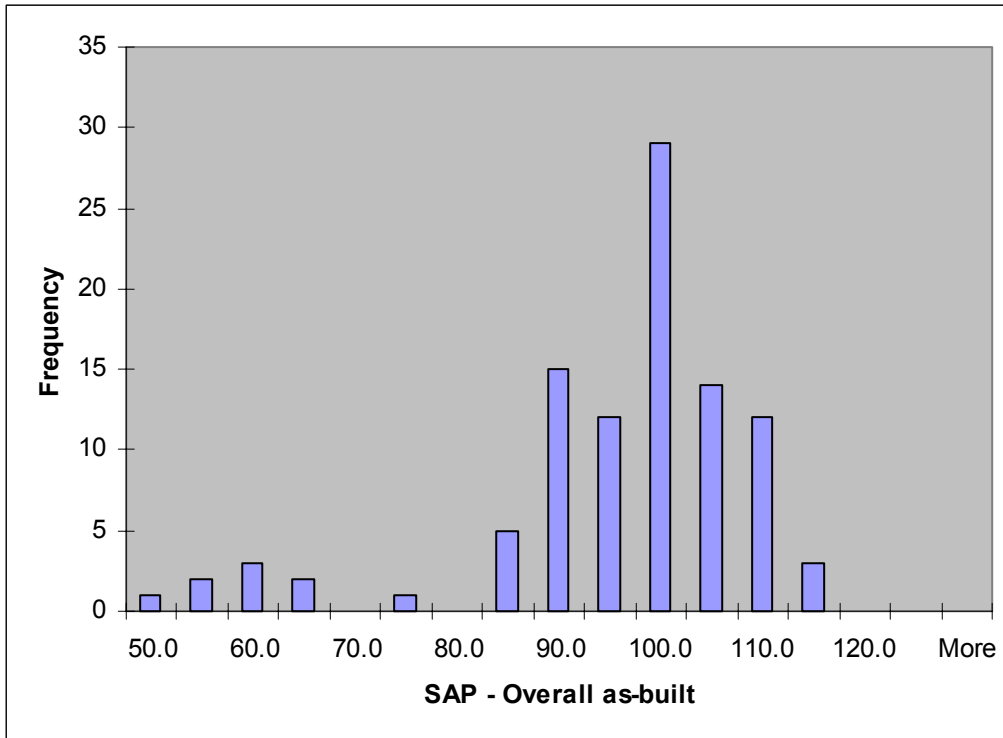
Figure 11 shows the SAP re-calculated on the basis of the observed boiler details and air permeabilities. The as-built mean value of SAP was 93.9, with an average decrease among the sample of 1.6 (an average worsening of 1.6 SAP points).

Figure 11. SAP resulting from as-built boiler details and air permeabilities

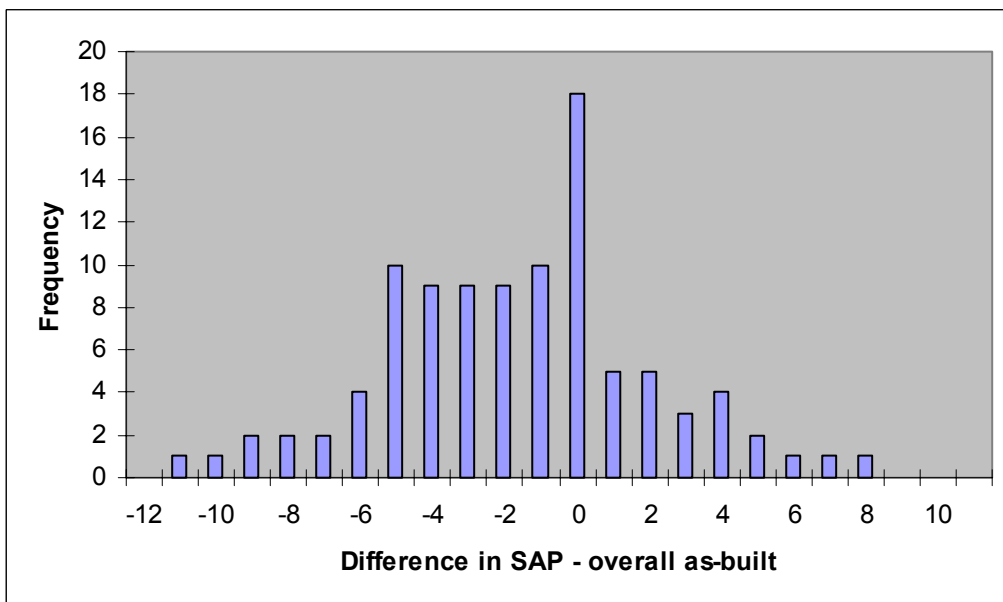
Figure 12 summarises the extent to which the resultant SAP differed from that of the original design specification. Positive values represent an improvement and negative values a deterioration in performance.

The differences shown in Figure 12 indicate that the as-built SAP ratings of most of the sample were worsened from those calculated for the initial proposal, with some decreasing by up to 11 SAP points.

Figure 12. Effect of as-built boiler details and air permeabilities on SAP

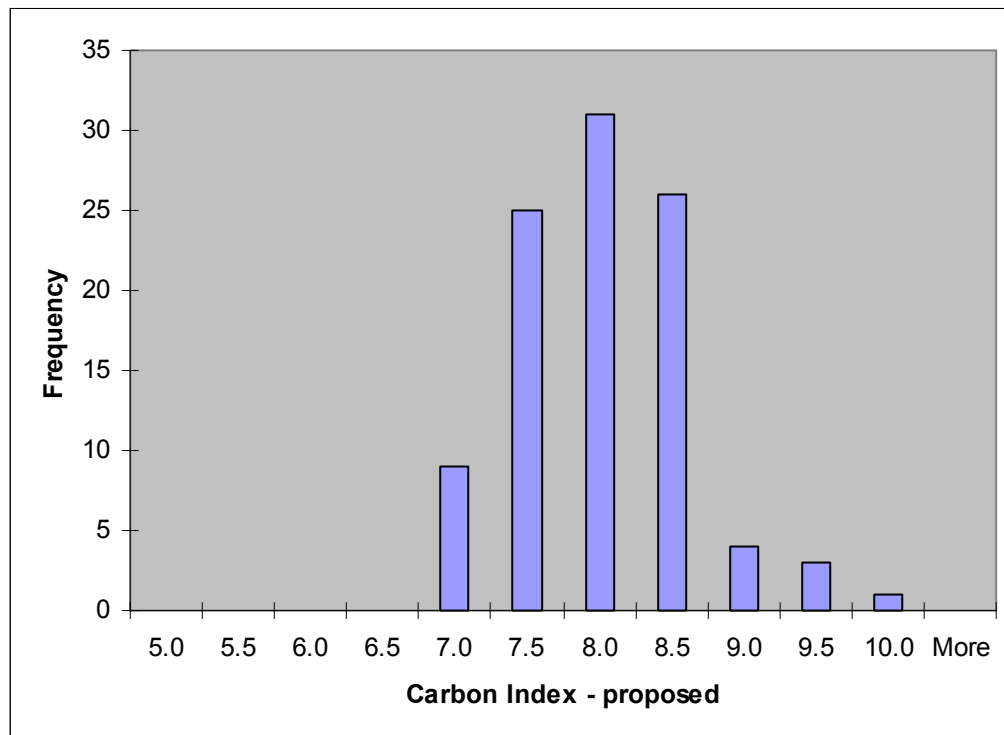
Figure 13 indicates the Carbon Index resulting from the 'as designed' dwelling specifications obtained by NES. Carbon Index varied from 6.7 to 9.7 with a mean value

of 7.83. Of the sample, 60% had achieved a calculated Carbon Index of less than 8 and would thus not have complied using this calculation approach.

Figure 13. Carbon Index calculated using 'as designed' dwelling specifications

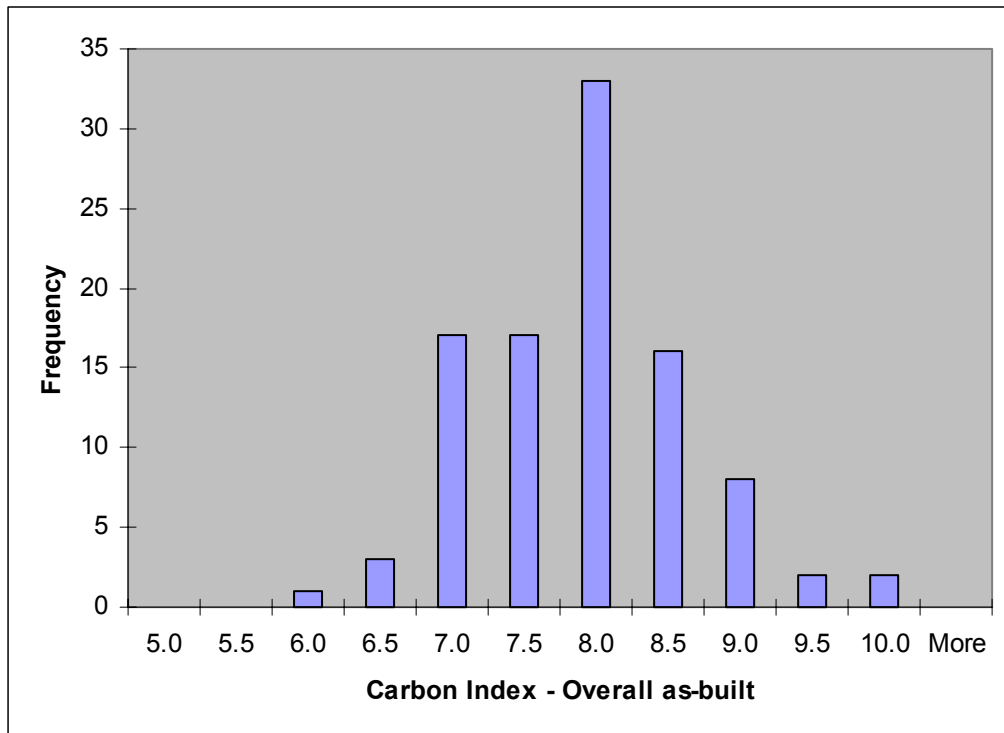
Figure 14 shows the Carbon Index re-calculated on the basis of all the observed details. The as-built mean Carbon Index was 7.71, with an average decrease among the sample of 0.12 (an average worsening in Carbon Index of 0.12). Of the sample, the proportion that had not achieved a calculated Carbon Index of less than 8 increased to 66%.

Figure 14. Carbon Index resulting from as-built boiler details and air permeabilities

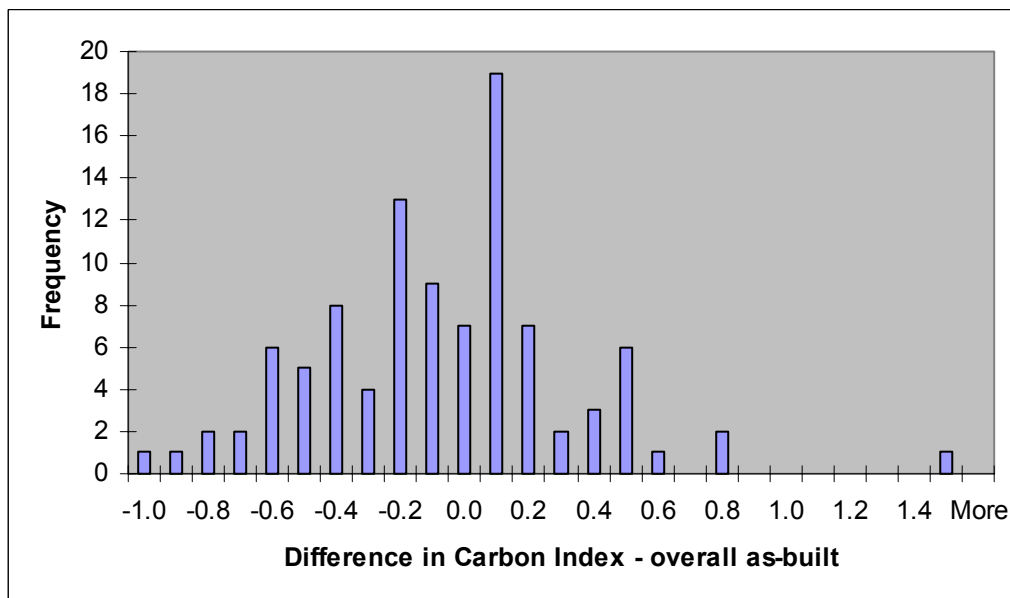
Figure 15 summarises the extent to which the resultant Carbon Index differed from that of the original design specification. Positive values represent an improvement and negative values a deterioration in performance.

The differences shown in Figure 15 indicate that the as-built Carbon Index of most of the sample was worsened from that calculated for the initial proposal.

Figure 15. Effect of as-built boiler details and air permeabilities on Carbon Index

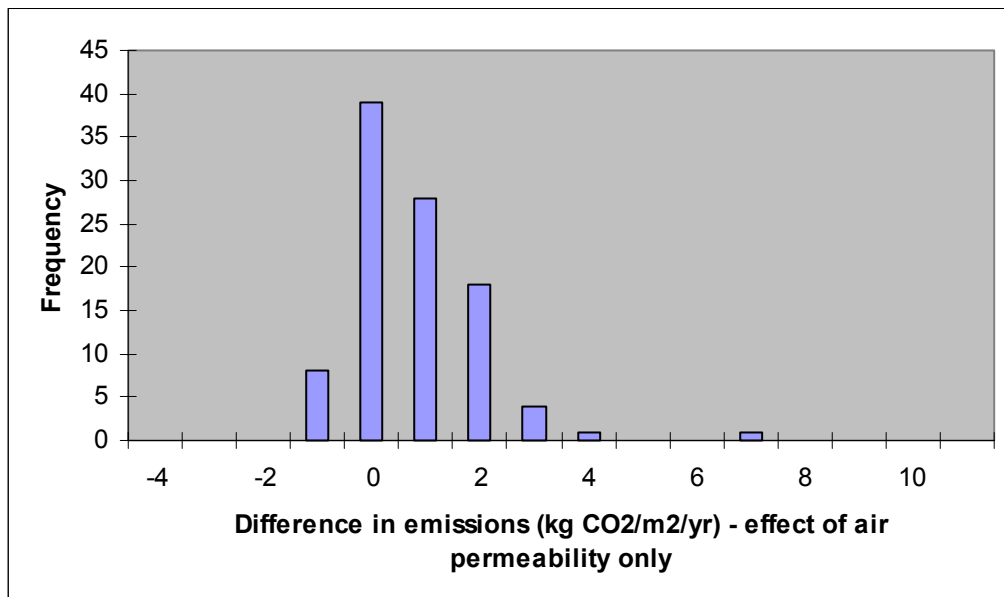
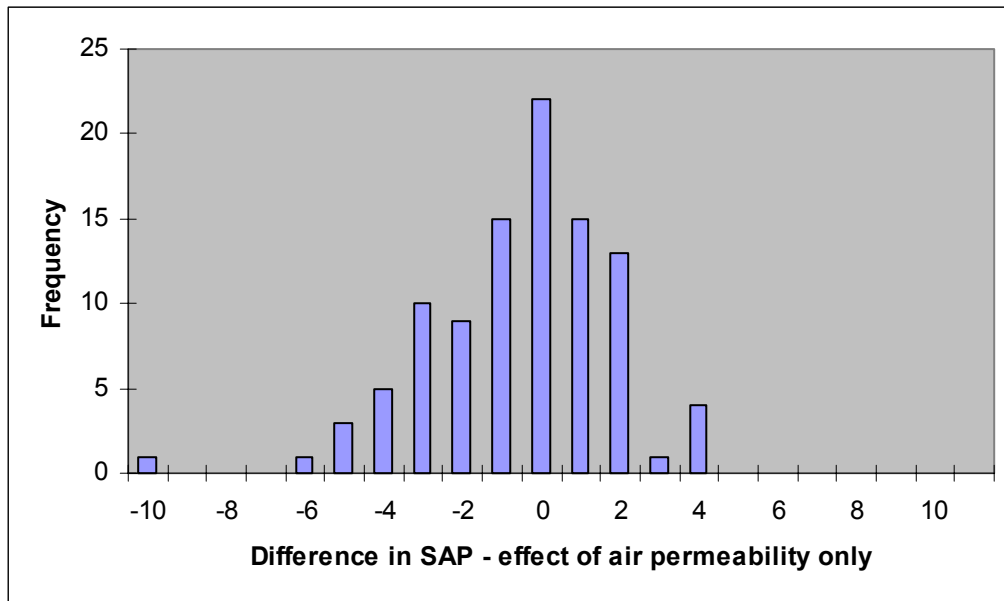
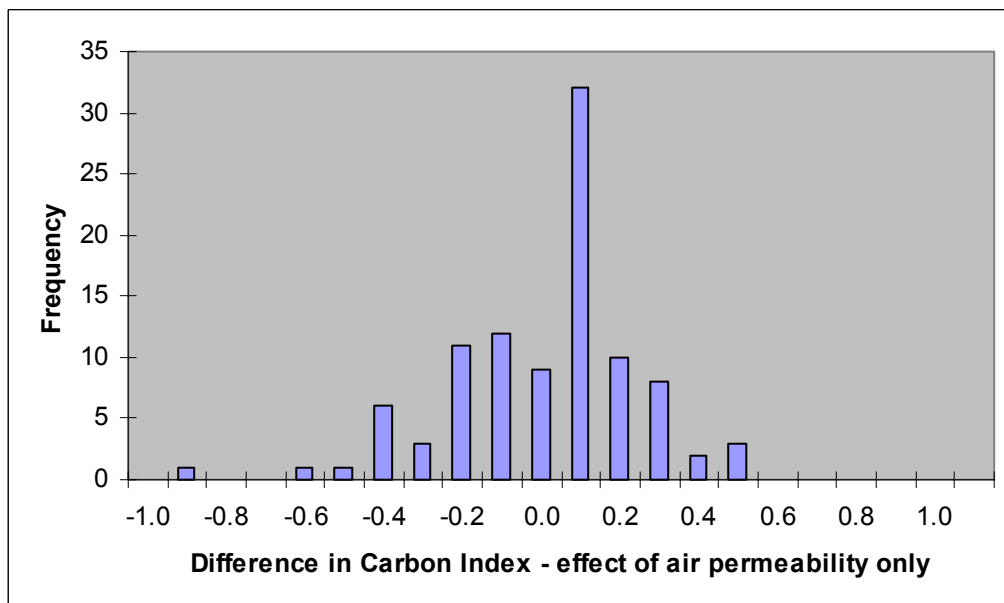
The individual effects of as-built air permeability on carbon dioxide emissions, SAP and Carbon Index are indicated in Figures 16, 17 and 18 respectively. The average effects among the sample were:

- An increase in carbon dioxide emissions of 0.32 kg/m²/yr.
- A decrease in SAP of 0.55 (worsening of 0.55).
- A decrease in Carbon Index of 0.04 (worsening of 0.04)

Figure 16. Individual effect of as-built air permeability on carbon dioxide emissions

Figure 17. Individual effect of as-built air permeability on calculated SAP

Figure 18. Individual effect of as-built air permeability on calculated Carbon Index

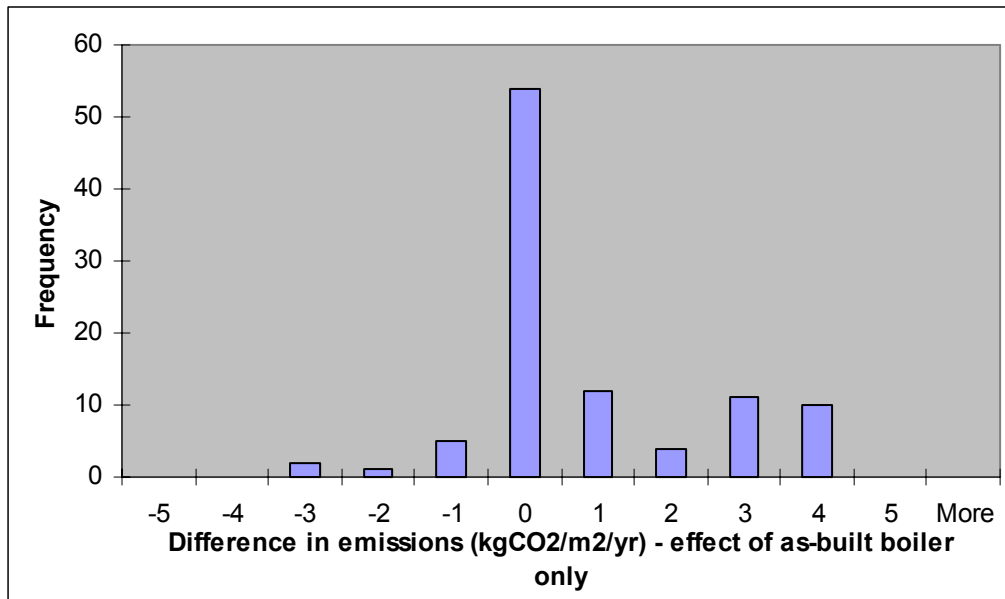
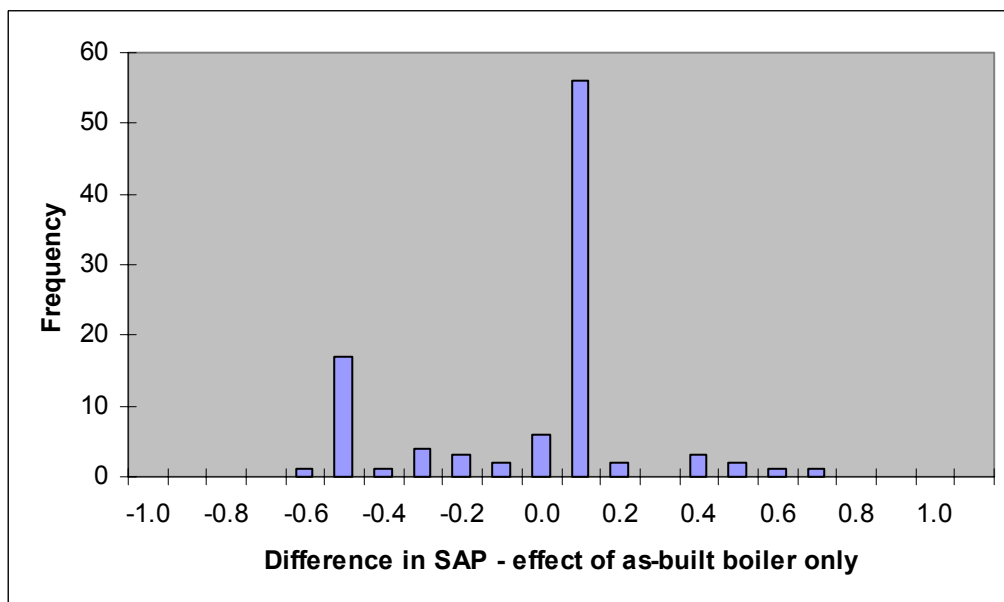
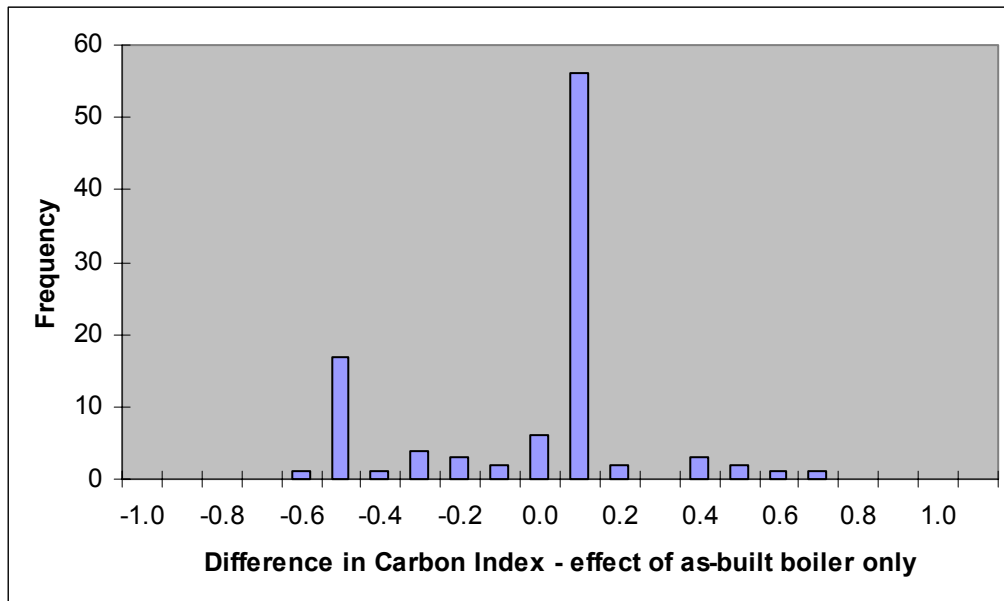
The individual effects of the as-built boiler on carbon dioxide emissions, SAP and Carbon Index are indicated in Figures 19, 20 and 21 respectively. The average effects among the sample were:

- An increase in carbon dioxide emissions of 0.64 kg/m²/yr.
- A decrease in SAP of 1.2 (worsening of 1.2).
- A decrease in Carbon Index of 0.11 (worsening of 0.11)

Figure 19. Individual effect of as-built boiler on carbon dioxide emissions

Figure 20. Individual effect of as-built boiler on calculated SAP

Figure 21. Individual effect of as-built boiler on calculated Carbon Index
